June 01, 2017

RE: Pacific Shores VIS 2036 – 700 Block Wood Rot Update

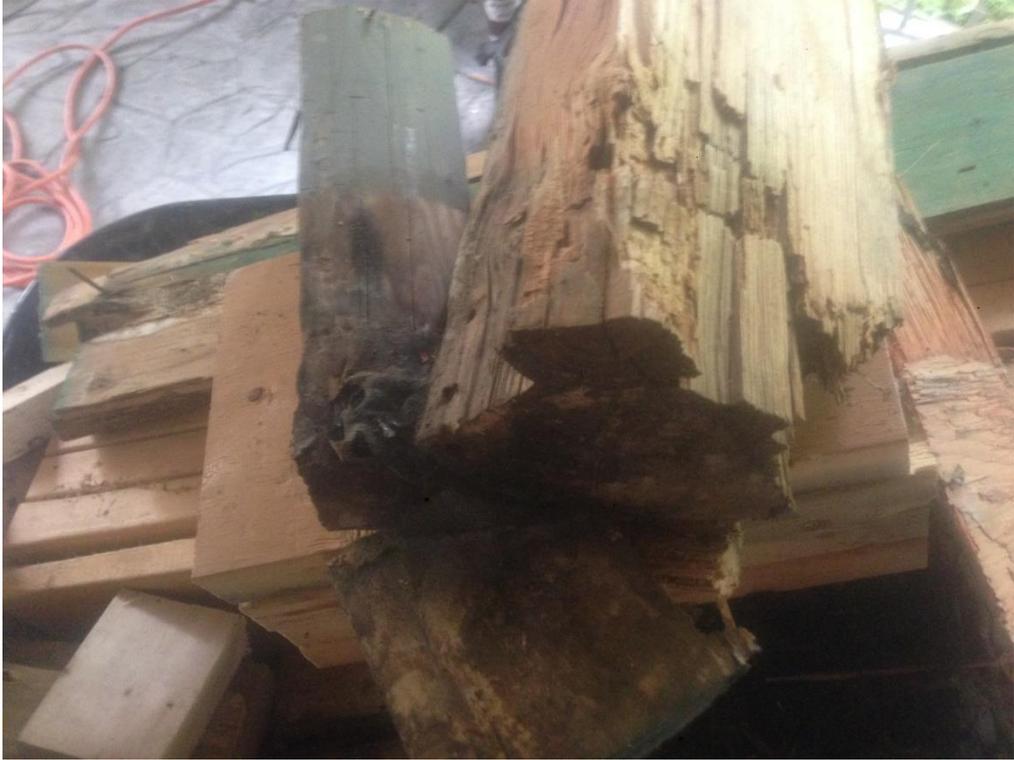
Per my report regarding the 700 Block 3<sup>rd</sup> floor, the water damage to the column did cause wood rot but has also compromised the bearing end of the supporting beam that runs from the lower column to the exterior wall of Unit 726. The beam will need to be replaced which necessitates additional removal of concrete topping, membrane, sheathing, siding, flashing, and framing. This will also require more shoring and supports as our replacement shifts along the hallway.

Wood rotted column base

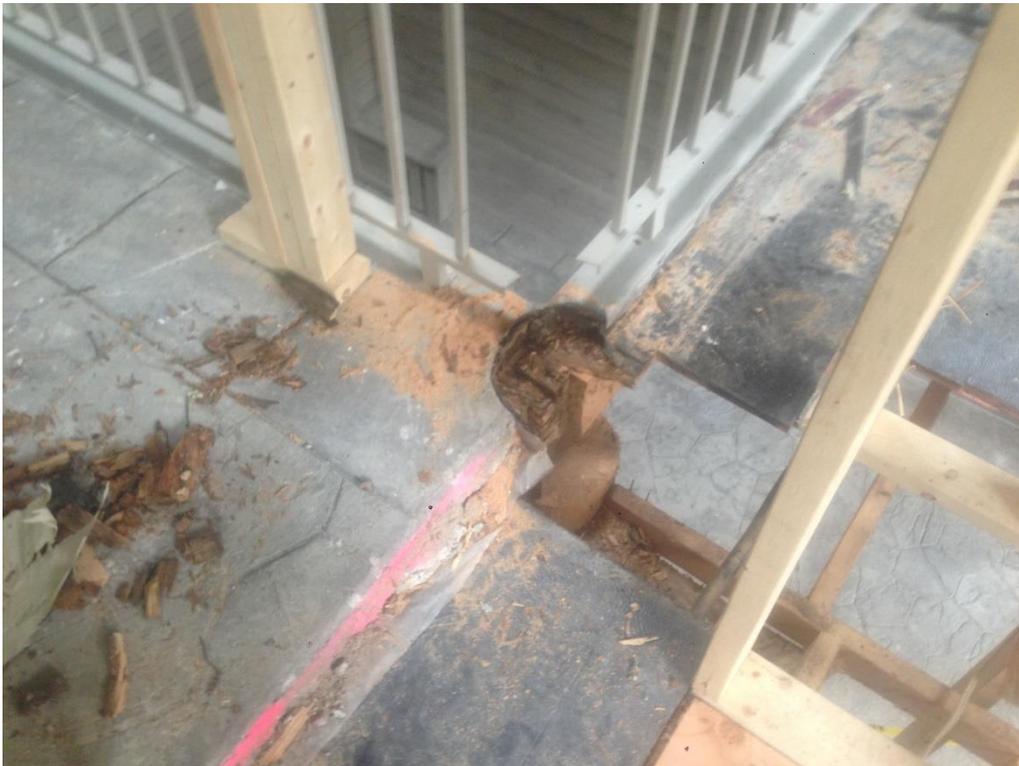
During recent work and site meetings, of which you were a part of, we discovered additional wood rot in the second floor inner corner column (nearest skylight) and the underlying beam after removal of concrete topping, membrane and sub-floor sheathing (see below photos). We also found wood rot in the beam running from the corner of Unit 717 to the outside post above the parkade and additional wood rot around the outside face of the stairwell on the main level and into the stairwell landing.

Inside corner column wood rot at second floor with underlying interior beam rot

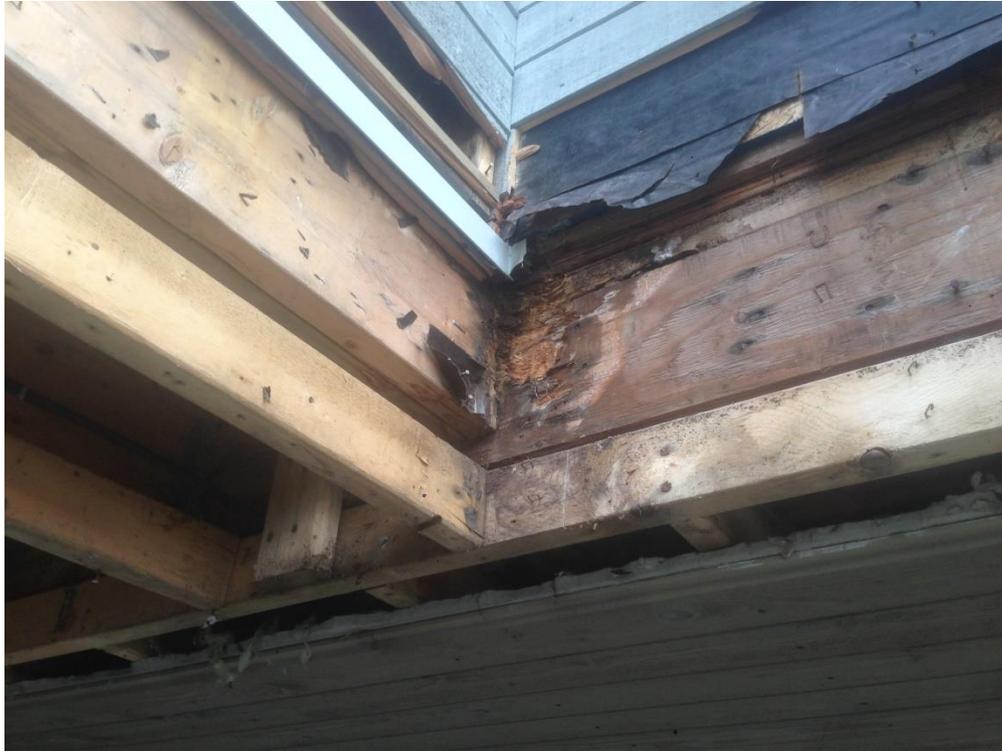
Wood rot at beam and wall plate above walkway adjacent to Unit 717

2. Demolition ( soffit and wall cladding, concrete topping, membrane, sheathing, drop-down framing, and beams)
3. RE/RE existing second floor guardrail
4. Install new beams; reconnect all joists
5. Install new membrane, flashing and sealants (new membrane will be fully adhered and second loose lay ply will be installed to protect base layer).
6. Install stamped concrete topping to match existing (colour match will be done as best as can be but weather staining and pedestrian traffic wear of existing adjacent area cannot be duplicated).
7. Install new cladding.
8. Install new corner flashing at Unit 717 walkway to wall intersection to mitigate future water ingress at this location.

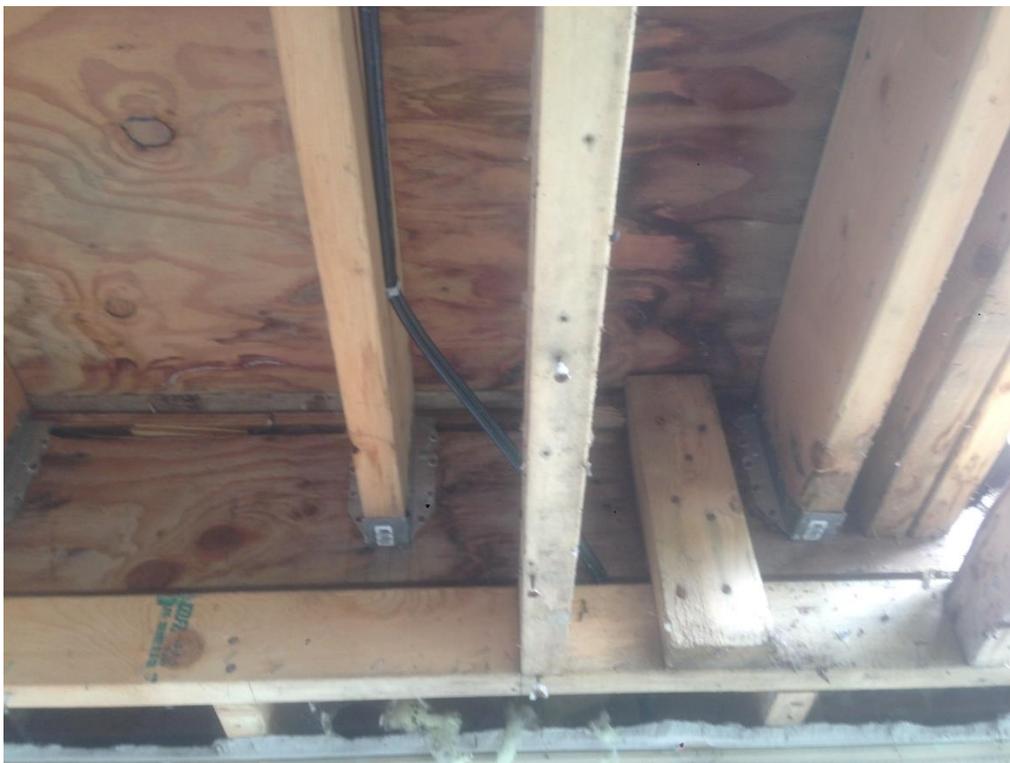
Removal of the exterior siding at the second floor walkway above the parkade showed that there was wood rot in the intersection of the walkway with Unit 727. The rot has affected the four ply level beam, floor plate, sheathing, and some of the walkway joists (which were to be replaced due to rot at opposite

Wood rot and water staining at walkway sheathing at entry to Unit 727

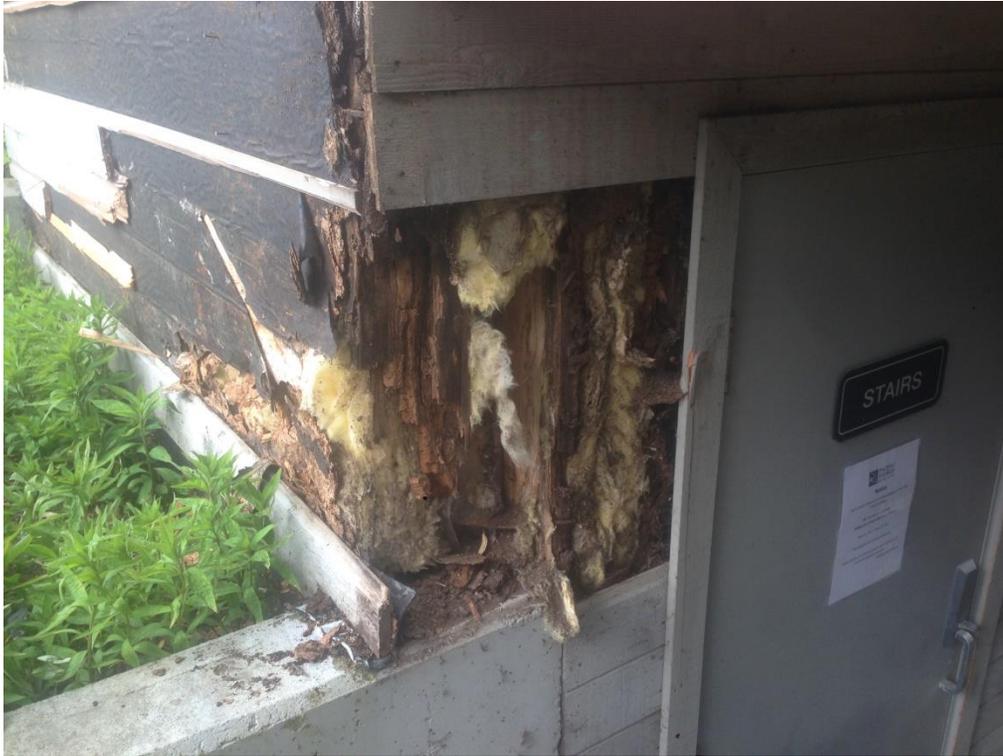
We have found that the wood rot in the stairwell wall at the main level has expanded into the second floor stairwell landing as well as around the exterior corner to the exposed face of the stairwell. This rot has significantly compromised all structural members in that area, causing the binding of the steel door due to crushing of rotted framing members.

Wood rot at exterior face of stairwell main floor

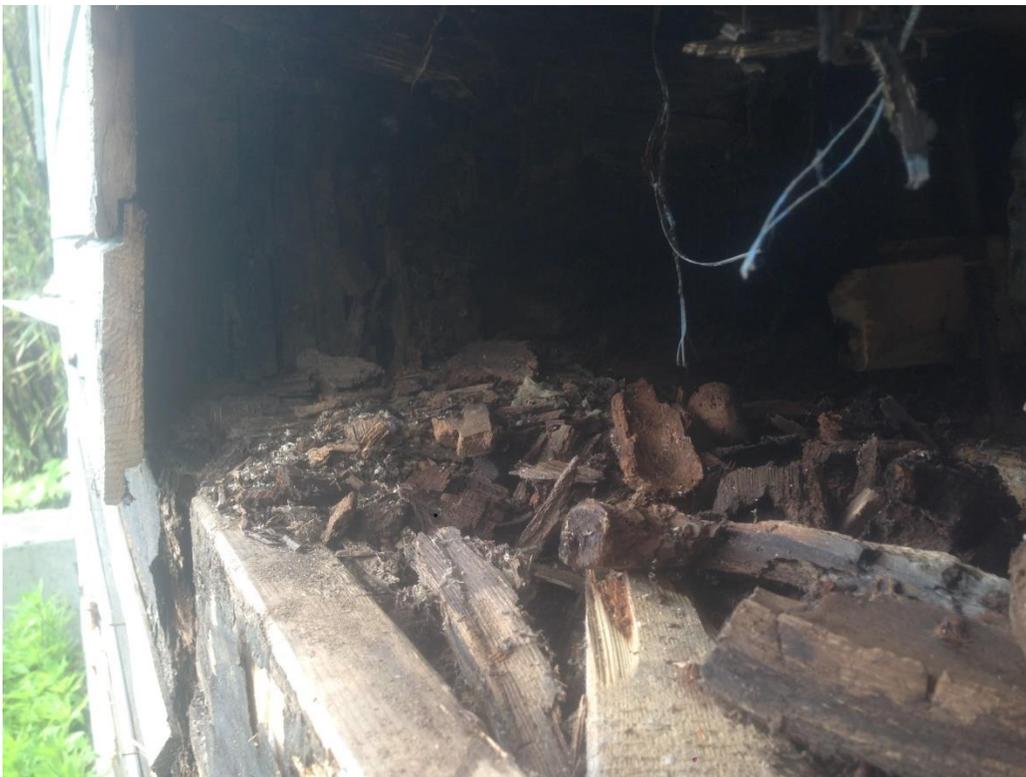
Wood rot at stairwell second floor landing framing
